INDOOR AIR QUALITY ASSESSMENT

**Pepperell Town Hall
1 Main Street
Pepperell, Massachusetts**

Prepared by:
Massachusetts Department of Public Health
Emergency Response/Indoor Air Quality Program
Bureau of Environmental Health Assessment
June 2003

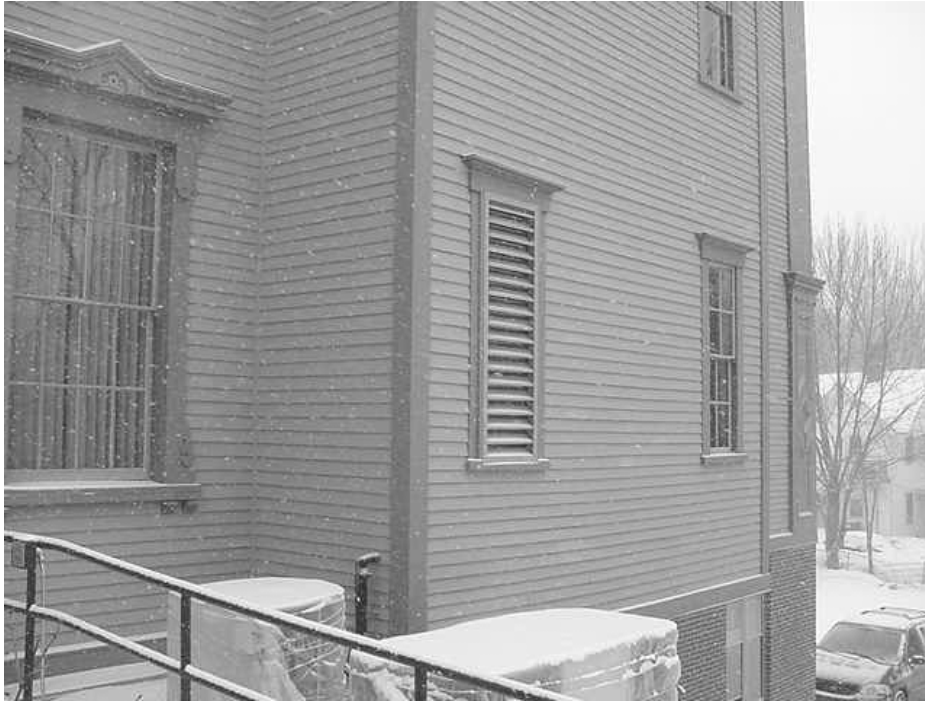
Picture 1

There are several HVAC systems in the building, all of which were deactivated during the assessment. An air-conditioning air-handling unit (AHU) was installed in the rear of the first floor. This AHU services office space on the first floor only. The fresh air intake for this system is installed in the exterior wall behind the town hall (see Picture 1). Air is distributed by diffusers connected to ductwork. The return vent for this AHU is installed in the rear wall of first floor offices (see Picture 2). The return vent was sealed with plexiglas to prevent cold air penetration into the office. The basement level has an AHU connected to ductwork whose sole purpose is to recirculate air. The auditorium has fan coil units (FCUs) that provide heat in cold weather, but do not introduce fresh air while operating (see Picture 3).

Fresh Air Intake, First Floor

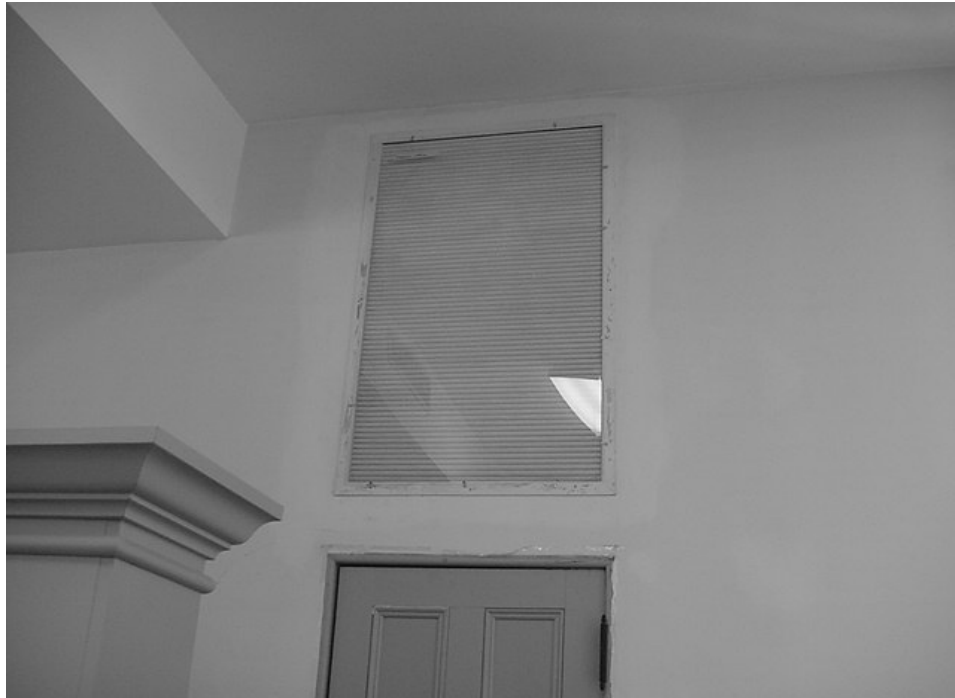
Picture 2

Return Vent Sealed with Plexiglas, First Floor

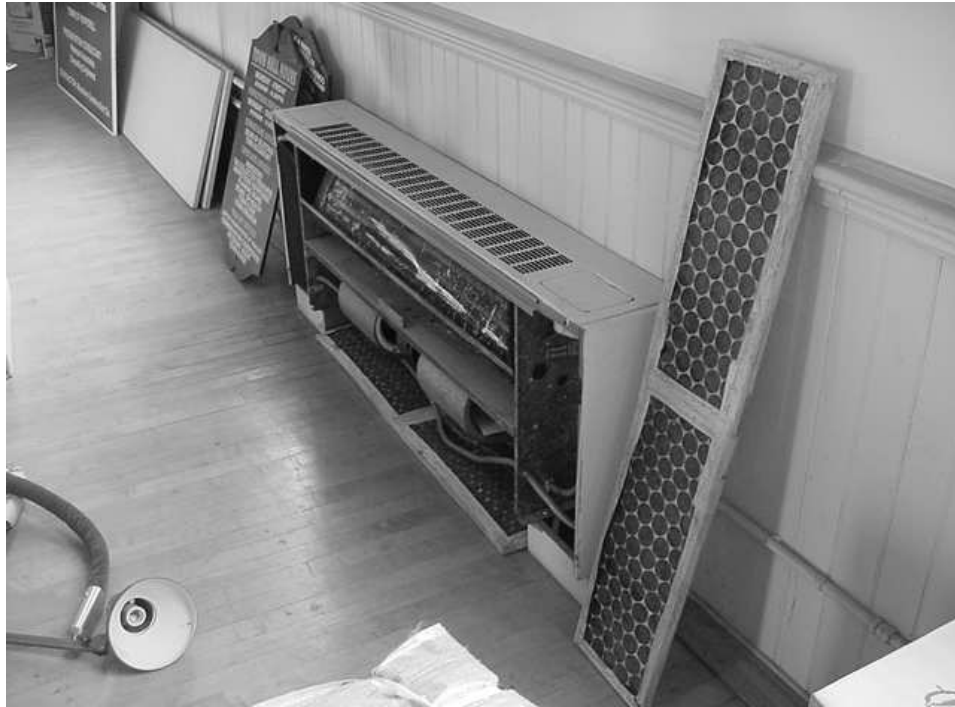
Picture 3

Auditorium FCU

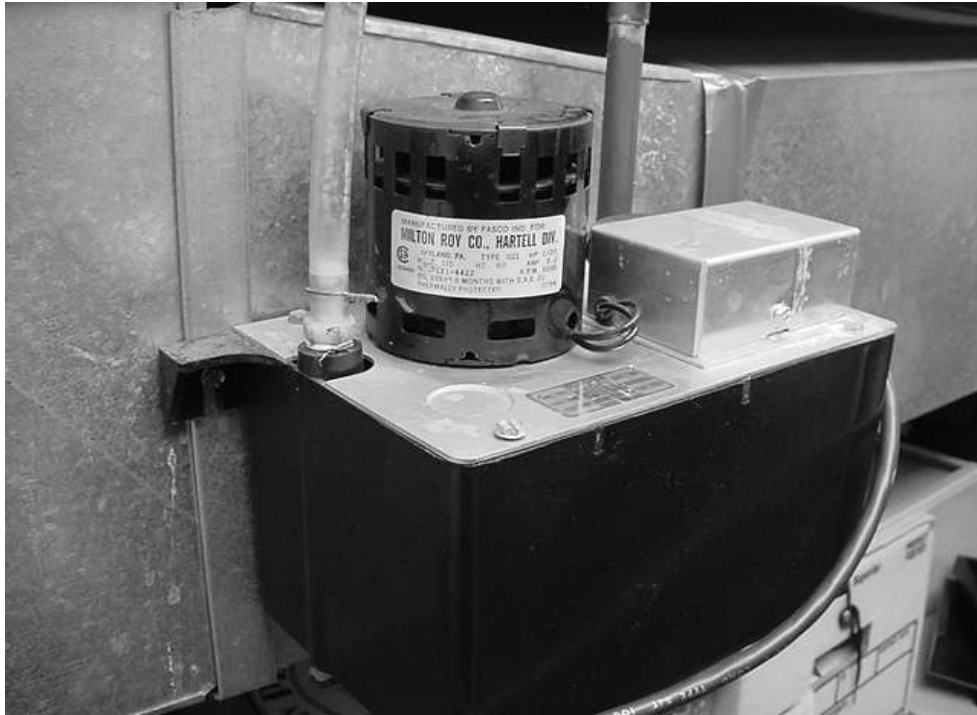
Picture 4

The HVAC system has the capacity to provide air conditioning during warm weather. Each AHU has a metal pan/condensation drain system installed. When warm, moist air passes over a surface that is colder than the air, water condensation can collect on the cold surface. Over time, water droplets can form, which can then drip from the suspended surface. For this reason, HVAC systems are equipped with drainage pans beneath cooling coils to drain condensate that forms as moist outdoor air is cooled. The AHU condensation pan on the ground floor empties into a condensation pump (see Picture 4). The pump is connected to a pipe system that drains water from the unit. Each pump should become activated once water accumulates within the base of the unit. The pump and attached hose (see Picture 5) appeared to be coated with debris that would serve as a medium for microbial growth.

Condensation Pump, Ground Floor HVAC System

- 5) Clean the AHU condensation pump and replace attached plastic hose. These pumps should be inspected for function every spring prior to activation of the air-conditioning system. Water should be poured into condensation pans and monitoring water removal. The interior collectors for condensation drains should be cleaned before and after the cooling season to prevent the accumulation of media that could support mold growth.

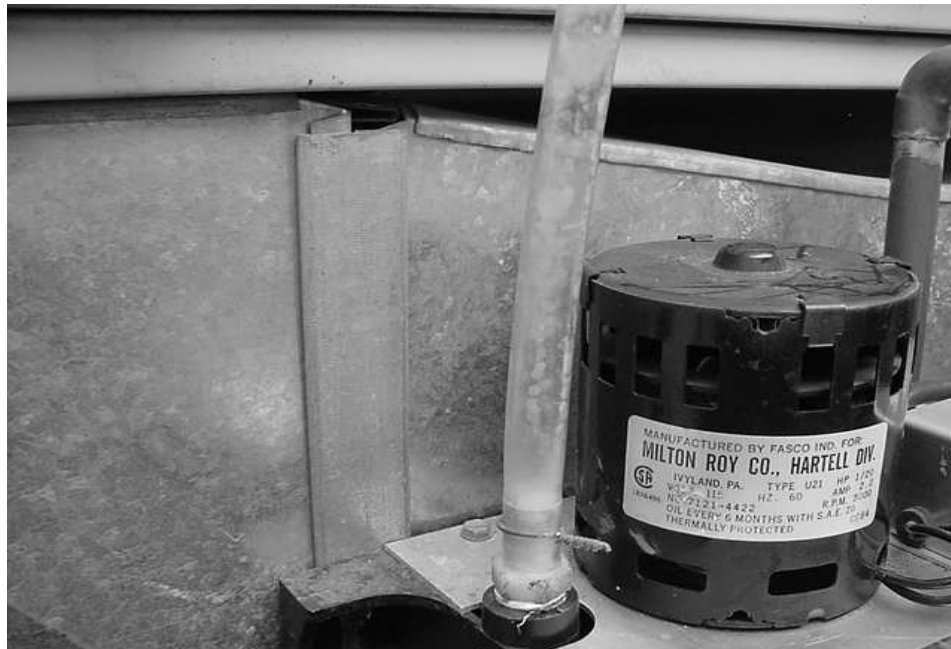
Picture 5

Hose to Condensation Pump, Ground Floor HVAC System, Note Coating Inside Hose

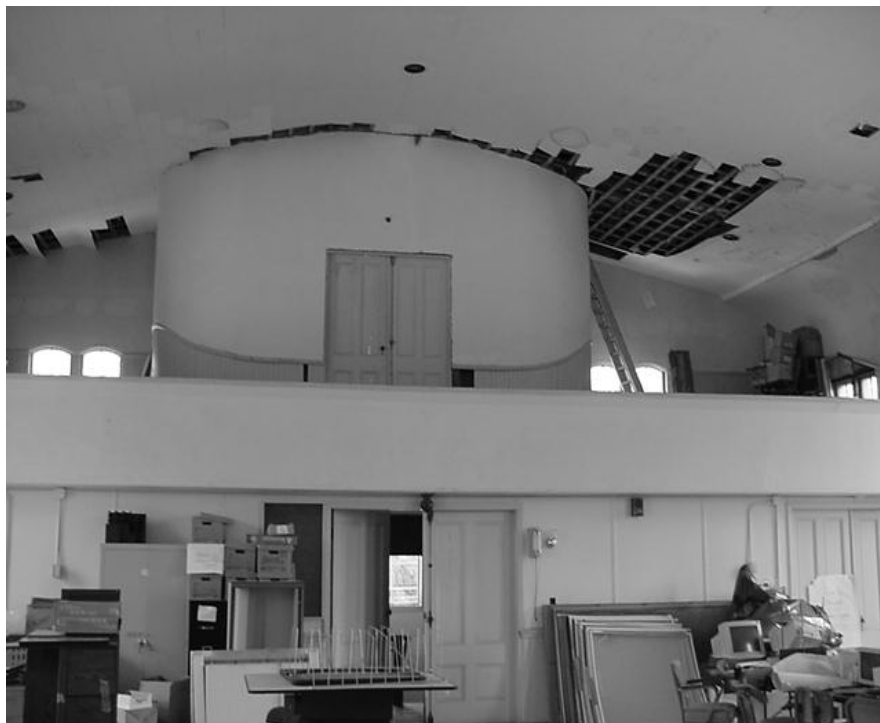
Picture 6

The auditorium has a ceiling tile system that is affixed directly to the ceiling lathe (see Picture 6). A significant number of ceiling tiles appear to be water-damaged by roof leaks. Water-damaged ceiling tiles may provide a medium for microbial growth and should be replaced after a water leak is repaired. Replacement of these ceiling tiles is

difficult, since their removal appears to necessitate the destruction of the tile, which can result in the aerosolization of particulates.

Ceiling Tiles, Auditorium

- 7) Reduce the number of plants in offices.
- 8) Water-damaged ceiling tiles should be replaced. These ceiling tiles can be a source of microbial growth and should be removed. Sources of water leaks (e.g. window frames and roof) should be identified and repaired. Once ceiling tiles are removed, examine the non-porous surface beneath and disinfect with an appropriate antimicrobial.

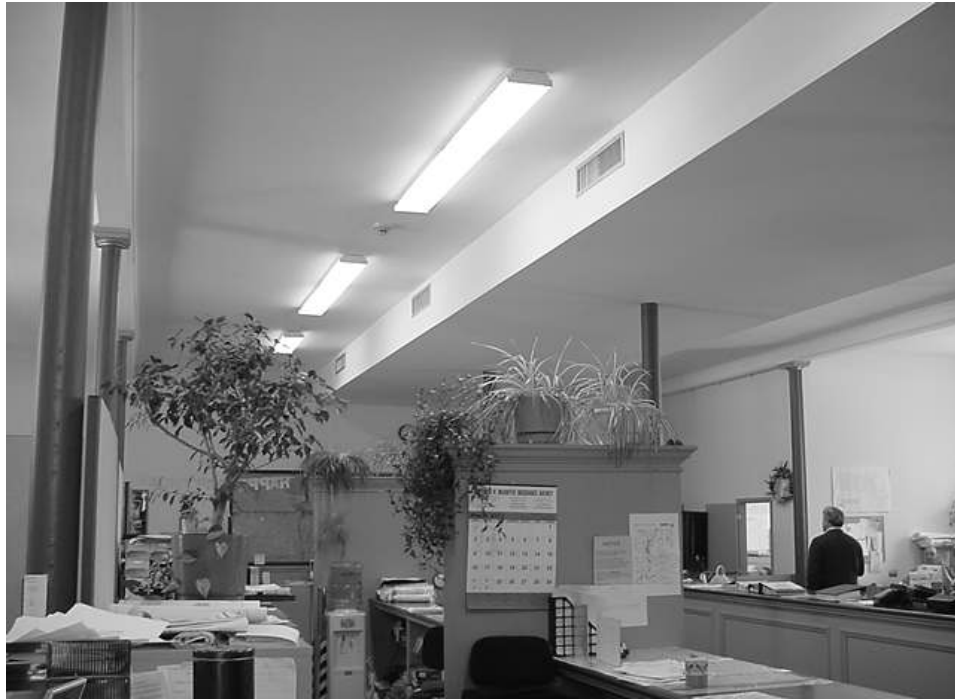
Picture 7

Several offices contained a number of plants (see Picture 7). Plant soil, standing water and drip pans can be a potential source of mold growth. Drip pans should be inspected periodically for mold growth and over watering should be avoided.

Plants, First Floor Offices

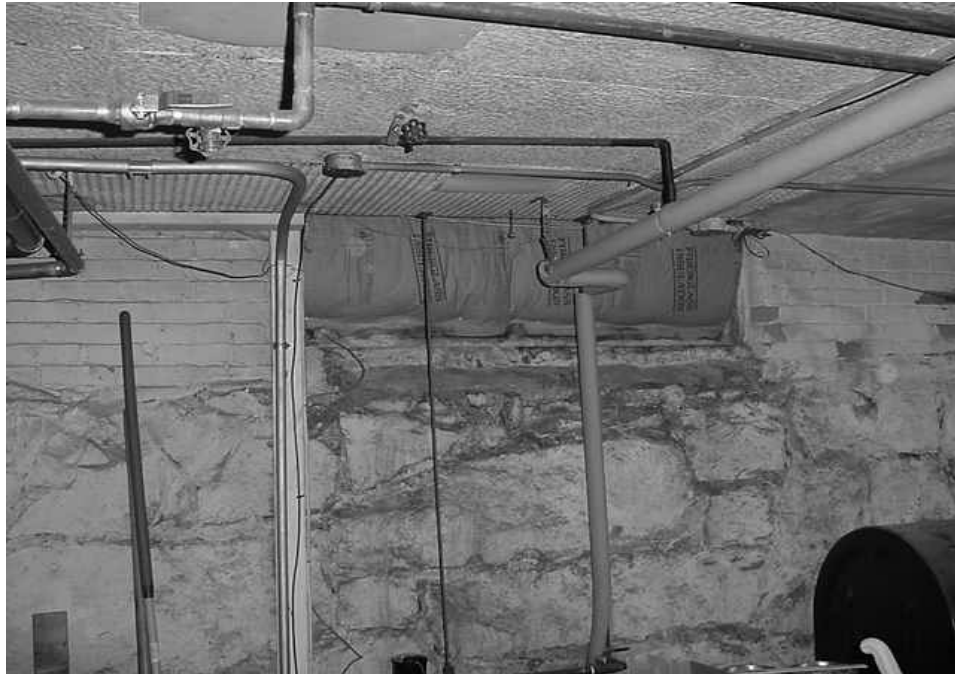
Picture 8

A gas-fired boiler is located in the basement. In order to provide efficient combustion for the gas jet in the boiler, an adequate supply of combustion air is needed to provide oxygen. A make up air vent is usually located in an area near the furnace. The make up air vent for the furnace was sealed with fiberglass insulation (see Picture 8). With the make up air vent sealed, combustion air is drawn from the interior of the building. This condition can result in incomplete combustion of fuel, which can produce by products such as carbon monoxide (CO). Due to the configuration of the water heater and its exhaust vent, CO measurements were taken in the basement prior to and after activation of the hot water heater. No detectable levels of CO were measured at any time during the assessment. However, a number of penetrations were noted in the walls and ceiling of the boiler room which can serve as pathways for boiler room pollutants to migrate into occupied areas (see Pictures 9 & 10).

Combustion Air Vent Was Sealed With Fiberglass Insulation, Boiler Room

- 1) Install a wall-mounted CO alarm with digital readout in the basement stairwell. CO levels should be checked daily after the boiler is fired up during the heating season.
- 2) Provide adequate combustion air for the water and space heaters. Restoring the fresh air intake in the boiler room is necessary. Consult with the local fire prevention officer/building code official to determine an appropriate method to provide combustion air.
- 3) Consideration should be given to rendering the boiler room as airtight as possible to eliminate the draw of combustion air to occupied areas. Measures would include:

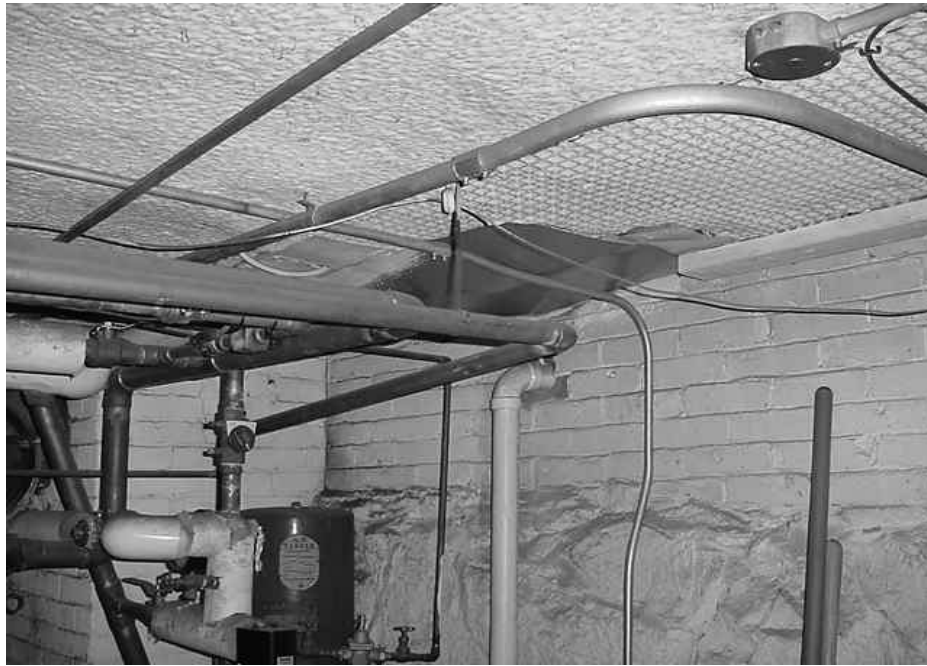
Picture 9

Ceiling and Wall Penetrations, Boiler Room

- i) Installing weather-stripping along the doorframe of the boiler room.
 - ii) Installing a door sweep at the bottom of the door of the boiler room door.

- iii) Sealing spaces around utility pipes that enter occupied areas through the floor.
- 4) Reseal/replace the sewer vent cuff in the first floor office closet to render the pipe airtight.

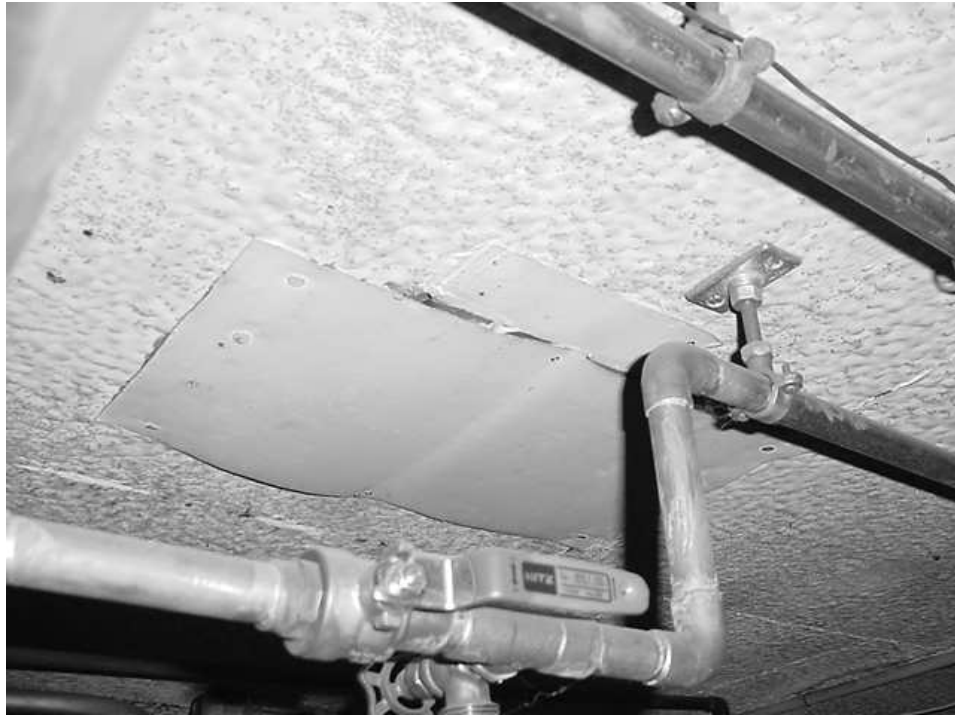
Picture 10

Ceiling Penetrations, Boiler Room (Note Spaces around Sheet Metal)

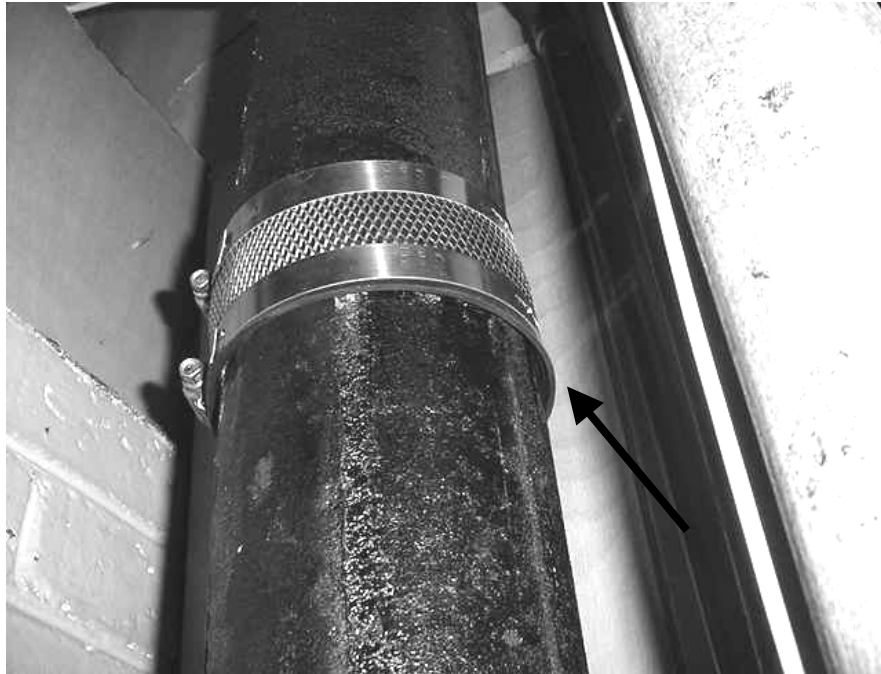
Picture 11

Sewer gas odors were reported in a closet of a first floor private office. Sewer gas odors were detected around a vent pipe in the closet (see Picture 11). Two sections of the vent pipe were joined to the floor pipe by a rubber-lined metal collar. The pipe running to the roof appeared to be slightly off-line with the floor pipe. This mismatched alignment resulted in bending of the rubber-lined clamp, creating a space in the interior of the vent pipe. This space allows for sewer gas to escape into occupied areas. Sewer gas can contain hydrogen sulfide, a gas heavier than air, which can be irritating to the eyes, nose and throat.

Sewer Gas Vent Pipe Cuff in the Closet, Note Buckling of Gasket

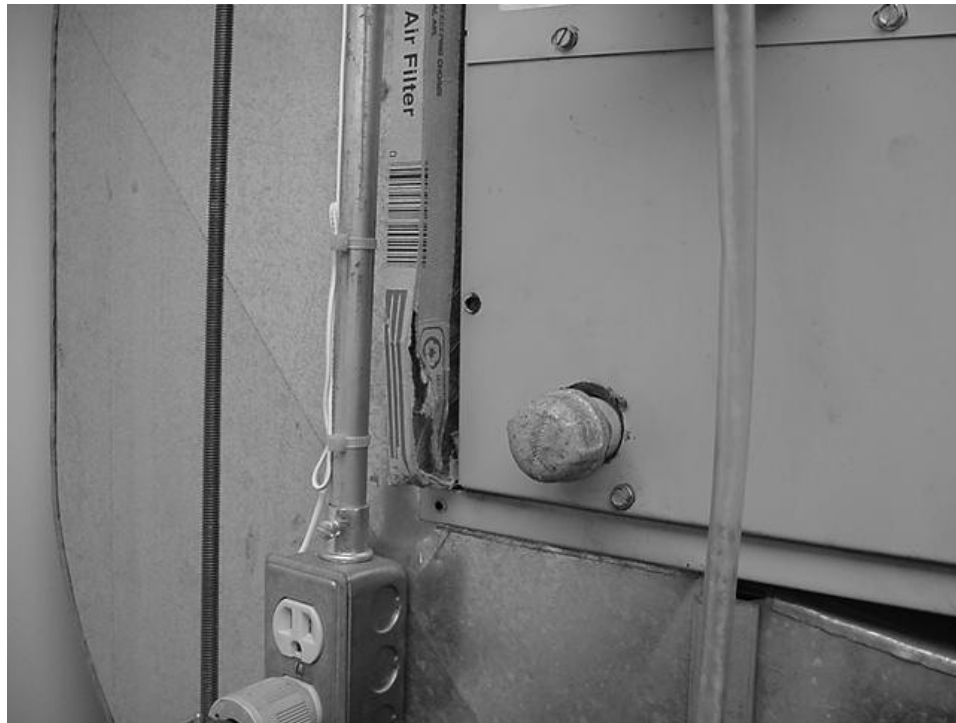
Picture 12

The various HVAC system components were equipped with disposable filters. Filters on auditorium FCUs were not fit into place. The frame of the filter in the ground floor AHU was damaged and no cover exists to seal the filter slot (see Picture 12). This can allow for unfiltered air to bypass the filter and be distributed by the FCUs during operation. The filter medium used in these metal racks provides minimal filtration of respirable particulates. In order to decrease aerosolized particulates, disposable filters with an increased dust spot efficiency can be installed. The dust spot efficiency is the ability of a filter to remove particulates of a certain diameter from air passing through the

filter. Filters that have been determined by ASHRAE to meet its standard for dust spot efficiency of a minimum of 40 percent (Minimum Efficiency Reporting Value equal to 9) would be sufficient to reduce many airborne particulates (Thornburg, 2000; MEHRC, 1997; ASHRAE, 1992). Note that increasing filtration can reduce airflow (called pressure drop) that can reduce efficiency due to increased resistance. Prior to any increase of filtration, each piece of air handling equipment should be evaluated by a ventilation engineer to ascertain whether it can maintain function with more efficient filters.

Damaged Air Filter, Ground Floor AHU
